Corrosion in Underground condition of Mild Steel plates in various soil varying textures

Abstract: The effect of soil and its mechanical properties on the steel metal plates is studied by using weight loss methods and electrochemical impedance spectroscopy. It is observed that intensity of attack and corrosion rate are dependent on soil texture and content of moisture in it. Corrosion rate is higher in clayey soil than in mixed and sandy soils. It is observed from the study that mild steel undergoes only less violent surface-level corrosion in studied duration when buried underground.

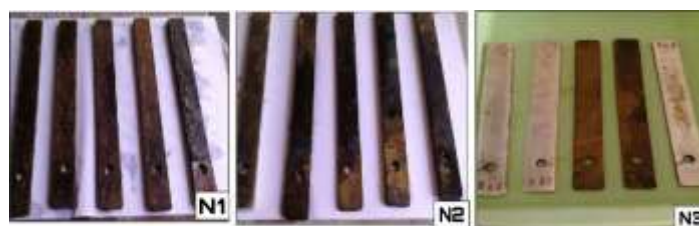
The affected specimens due to corrosion can provide some insight into the behavior of corrosion in different environments. The visual observation of all the coupons was performed, and few rusted samples from N1, N2 and N3 are shown in Fig1. It is found that most of the shiny surface of the specimens had turned dark brown, indicative of the adsorption of rust over the metal. However, corrosion pits were observed in a few spots of the coupons from N1 and N2.

Visual observation of the metal specimens revealed rust formation (dark brown color) over the metal surface with spotted pits. It is well known that the corrosion rate of the metal in the soil increases with an increase in moisture content till a critical moisture content (CMC) is reached. In the N2 zone, silty clay mixed soil has a plasticity index of 27%. The moisture content in the range of 30-35% is above the CMC, which indicates water saturation. The mixed silty clay, when spread over the surface, increases liquid dispersion, which accelerates corrosion. On the other hand, corrosion affects dissolution and diffusion in the bulk solution so that the water forms a liquid membrane around the silty clay, facilitating the diffusion of oxygen, which turns the sandy soil system more corrosive. However, the corrosion rate is low at the N3 zone, which is below the water table, because water surrounding the metal primarily controls the rate of diffusion of dissolved oxygen in the sandy soil system, which lowers the corrosion rate. Then the corrosion process is controlled by the charge transfer process, and then the overall process is controlled by a combination of activation and diffusion control. During the whole exposure period, the diameter of the arc at the higher-frequency region increases with an increase in depth level. This trend clearly indicates that the resistance of the metal is inversely related to the corrosion rate. The corrosion rate of the metal exposed to soil when placed underground was in the order $N1 > N2 > N3$.
